Rock-Lifting Experiment on the Trail in Baxter State Park

By Lester Kenway

Originally printed in The Register, Vol. 18, No. 5, October 1995.

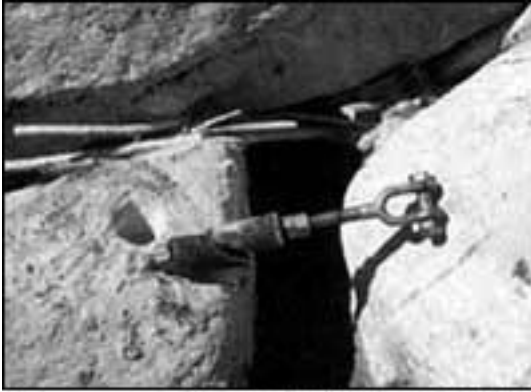
Figure 1

Expansion bolt next to hole

1. First, a hole was drilled to accept the expansion bolt. In this case, a 1 7/8-inch diameter hole, eight inches deep, was needed. The drilling took about five minutes.
2. Next, the bolt assembly was placed in the hole and expanded in place, leaving clearance for the bottom of the center rod. The expansion bolt was then rotated with a steel pipe in order to fit it tightly in the hole.
3. Next, rigging was attached to the eye of the bolt, and the rock was lifted from the ground.
4. Upon delivery, the bolt was loosened with a pipe, and the rod was removed. The remaining parts were fished out of the hole with a piece of wire.

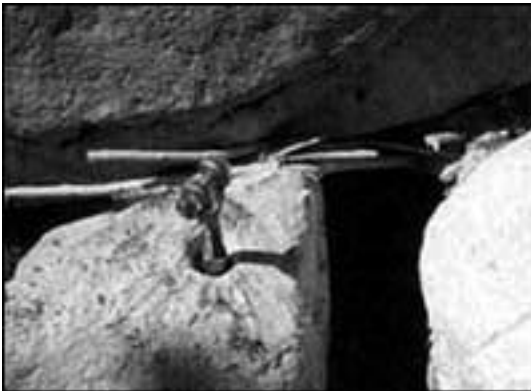
Figure 2

Expansion bolt placed in hole & tightened

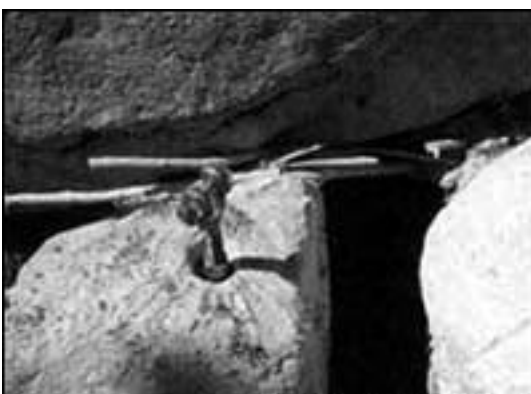
Figure 3

Snatch block attached to eye and ready for lift

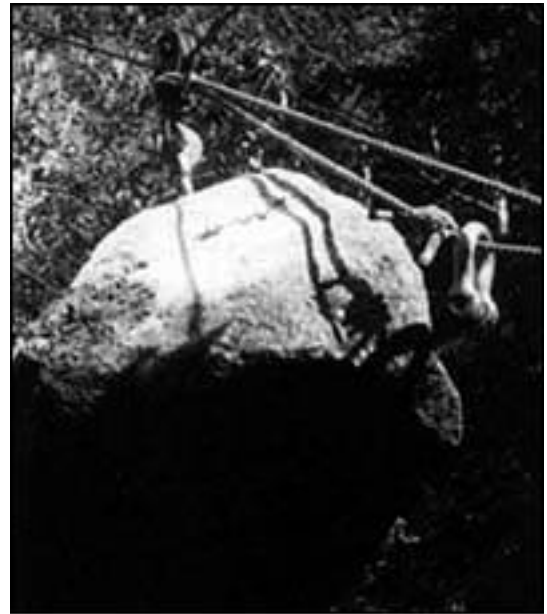
Figure 4

Rock lifted and headed for the Trail

During the experiment, more than 30 rocks, some weighing close to 1,000 pounds, were lifted without serious problems. Workers should be alert to the potential of rocks breaking loose, however, and should not place anyone at risk of being hit.
