# Hazard Trees

*Originally printed in The Register, Vol. 14, No. 4, August 1991*

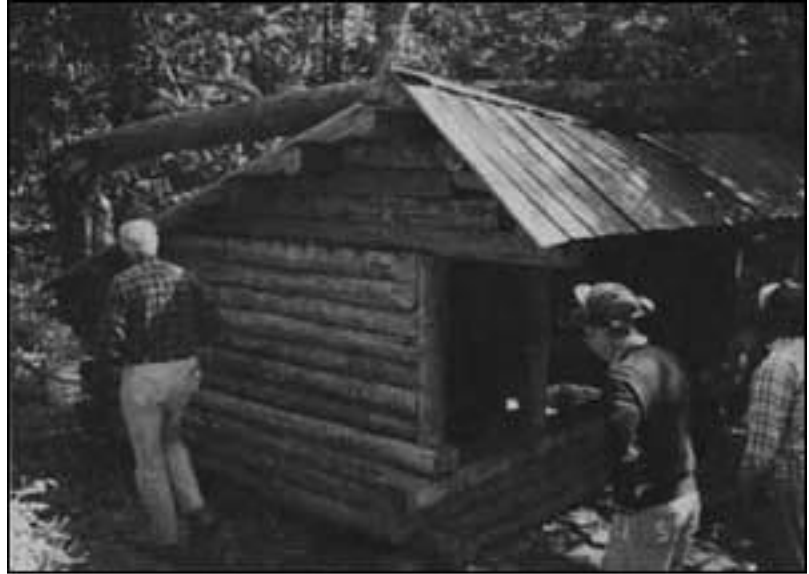
**Members of the Connecticut Chapter of the Appalachian Mountain Club inspect the damage to the Limestone Springs Shelter.**

The second incident occurred May 17, 1991, when the Limestone Springs Shelter in Connecticut was hit by a 60-foot ash during a rainstorm with high winds. Fortunately, the shelter was a solid, well-built lean-to, designed (using the model developed by the Maine A.T. Club) to withstand heavy snow loads. The falling tree cracked the ridgepole and woke a hiker asleep in the shelter. Unharmed, the hiker decided to remain inside the shelter for the rest of the night instead of sleeping out in the rain. Subsequent inspection by members of the Connecticut Chapter of the Appalachian Mountain Club revealed that the tree was partially hollow and partially filled with dry rot, despite its outwardly healthy appearance.
